# Cooling Water Pipeline Internal Coating

ID: 10395

| Industry: | Power | Customer Location: | Ratchaburi, Thailand |

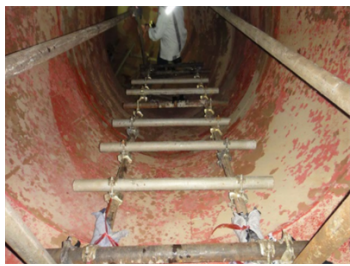
The client experienced severe internal corrosion within the cooling water pipeline system due to failure of the previously applied antifouling paint and epoxy coating. The existing coating system exhibited poor adhesion performance and began to peel off after approximately 3 years of service, particularly in high-turbulence areas such as elbows, reducers, risers, and beneath the condenser waterbox sections, where flow velocity and turbulence are significantly higher.

In addition, extensive coating disbondment was observed at welding joints. During plant construction, field welding activities were carried out after the original coating application, requiring localized coating touch-up at the weld areas. However, the touch-up process was performed without proper abrasive blasting or adequate surface preparation, resulting in an insufficient surface profile and poor mechanical adhesion between the substrate and the coating system.

Consequently, premature coating delamination and under-film corrosion developed at these locations during operation.

Inspection of the damage

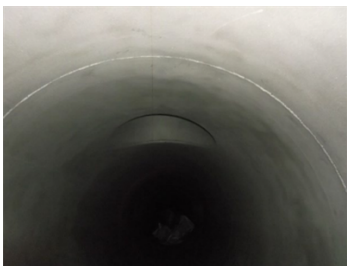
Grit blasting was completed before the coating application

2. All carbon steel surfaces were abrasive blasted using copper slag abrasive to achieve a surface cleanliness of Sa 2.5 in accordance with ISO 8501-1. Surface profile was maintained at approximately 75 microns to provide adequate mechanical anchorage for the coating system.
