# 20 YEAR OLD BELZONA PUMP COATING

Industry: Power  
Application: CEP-Centrifugal Pumps  
Substrate: Cast Iron  
Products: \* Belzona® 1321 (Ceramic S Metal) ,

Customer Location: Power Plant, Yates, Texas  
Application Date: 1988

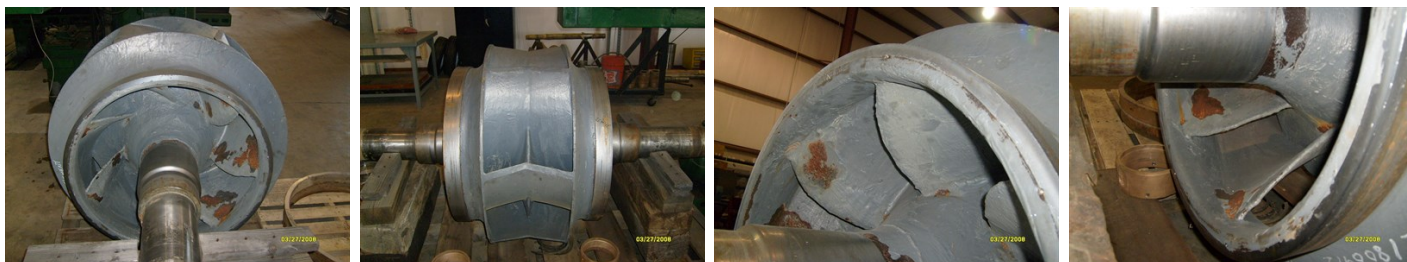
## Photograph Descriptions

- \*
- \* Cavitation Damage ,
- \* Vanes in like-new condition ,
- \* & 4 Closeup of localized cavitation damage. Note no corrosion creep under the coating ,
- ,

Inspection of the coated impeller showed it to still be in excellent condition with only small areas of cavitation damage. Coated pumps have proven themselves to far outlast uncoated ones, minimizing maintenance costs and downtime.

Application was carried out in accordance with Belzona Know-How System Leaflet CEP-3.
