# BELZONA CLEARS CLARIFIER PROBLEM

**Industry:** Water / Wastewater  
**Application:** TCC-Tanks and Chemical Containment Areas  
**Substrate:** Aluminum  
**Products:** Belzona® 3921 (GSC Conditioner) Belzona® 5811 (immersion Grade),

**Customer Location:** Waste Water Utility, Oklahoma  
**Application Date:** March, 2007

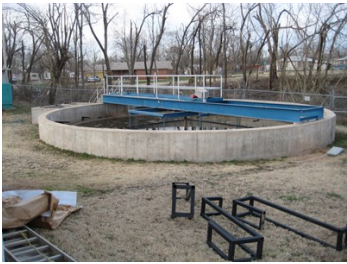
Clarifier

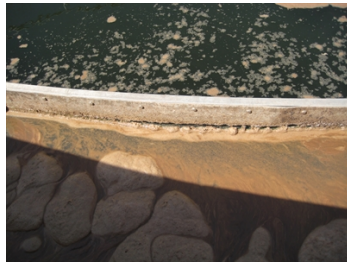
50% of the shield had been eroded away due to corrosion at the water line. A new skirt from the manufacturer would cost over \$15,000 and take unduly long to install.

Eroded Aluminum

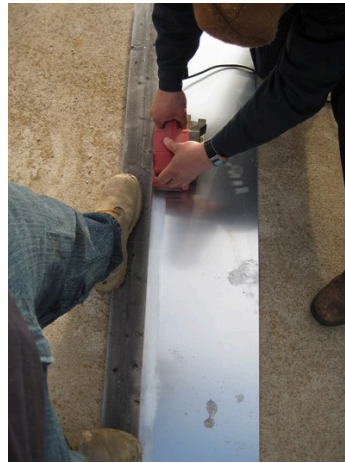
Preparing the panels

Abraded new aluminum panels and coated with Belzona® 3921 and Belzona® 5811 in accordance with Belzona Know-How System Leaflet TCC-5. The panels were then bolted to the sound skirt eliminating need for complete replacement.

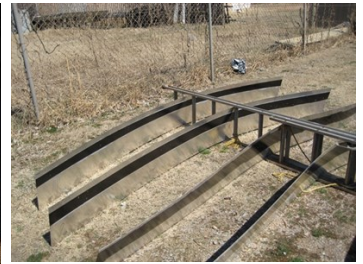
Finished panels coated at the waterline on both sides
