BELZONA REBUILDS LIFT PUMP

ID: 1047

Customer Location: Waste Water Utility, Oklahoma
Application Date: September 2006

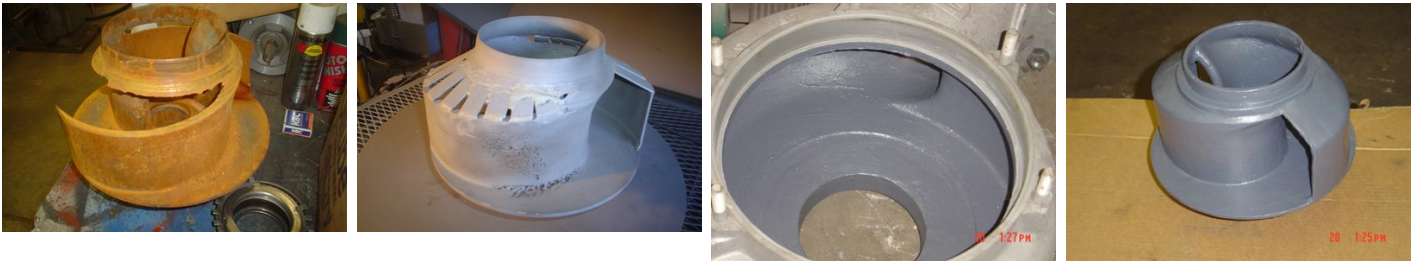
Photograph Descriptions

Pump had lost efficiency and had to be pulled. The model was foreign and had a four week lead time for parts.

- * Eroded impeller ,
- * Impeller reinforced and blasted ,
- * Blasted and coated bowl ,
- * Impeller after balance and rebuild ,

Application was carried out in accordance with Belzona Know-How System Leaflets CEP-1, CEP-3 and CEP-5.

This impeller and bowl was rebuilt in a local repair shop using Belzona for 40% of the cost of a new one. The customer reported that when reinstalled the check valve has never gone higher!
