# BELZONA REPAIR TO TURBO-PULPER

ID: 105

Customer Location: *UK Paper Mill*  
Application Date: *1998*

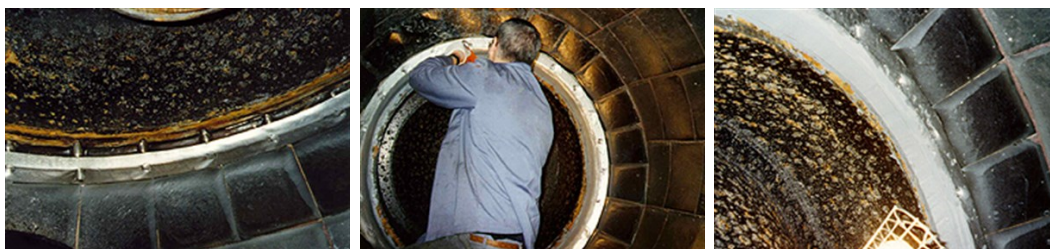
*Erosion from pulp had worn away the sealing ring exposing the stainless steel bolts.*

- \* The degree of erosion on the sealing ring and bolts clearly evident ,
- \* Application underway inside the pulper ,
- \* Sealing ring and bolts completely encapsulated with Belzona® 1111 ,

Application was carried out in accordance with Belzona Know-How System TCC-5.

To remove sealing ring and replace would have taken a long time and interfered with production. Belzona application carried out within normal shutdown period and has prevented further erosion of the sealing ring and bolts.
