# BELZONA PUMP REBUILD

ID: 1050

Application: CEP-Centrifugal Pumps

Customer Location: Water Utility, Oklahoma USA

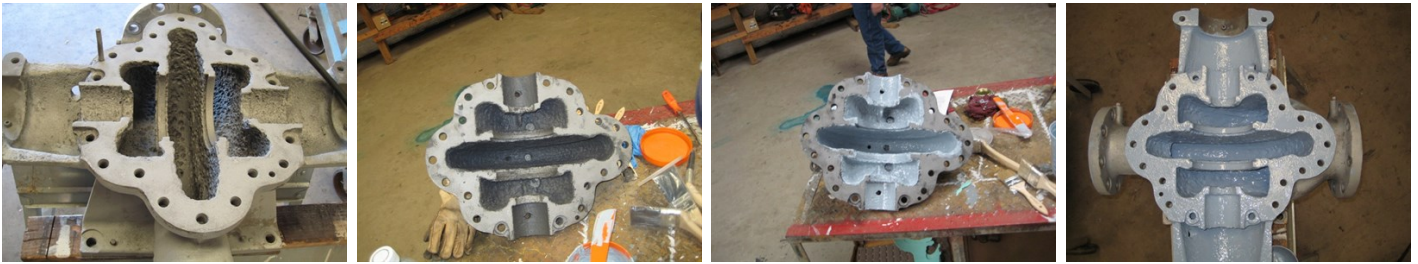
Many of the pumps have never been rebuilt and severe pitting was present. In some cases, it went almost through the casing.

- \* Pump casing after grit blasting ,
- \* Deep pitting repaired with Belzona® 1311 ,
- \* First coat of Belzona® 1341N applied ,
- \* Second coat applied to complete the application ,

Application was carried out in accordance with Belzona Know-How System Leaflets CEP-1, CEP-3, and CEP-5.
