BELZONA PUMP REBUILD

ID: 1050

Customer Location: Water Utility, Oklahoma USA
Application Date: March 2008

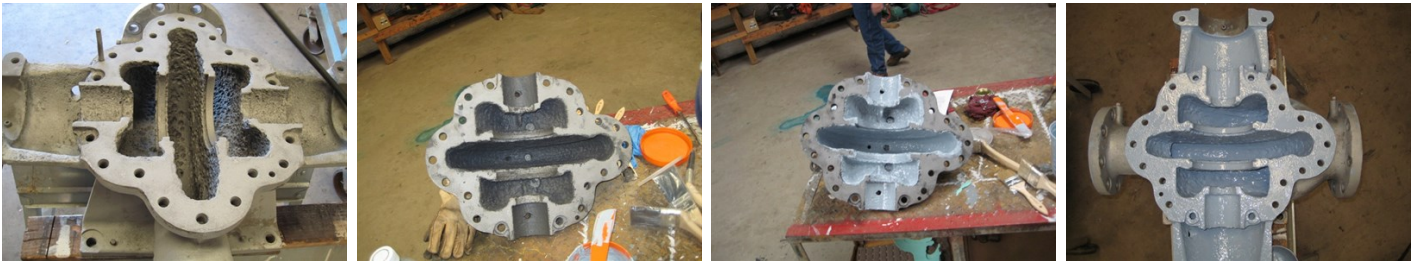
Photograph Descriptions

Many of the pumps have never been rebuilt and severe pitting was present. In some cases, it went almost through the casing.

- * Pump casing after grit blasting ,
- * Deep pitting repaired with Belzona® 1311 ,
- * First coat of Belzona® 1341N applied ,
- * Second coat applied to complete the application ,

Application was carried out in accordance with Belzona Know-How System Leaflets CEP-1, CEP-3, and CEP-5.

It is substantially more cost-effective to rebuild versus replace. The utility can do a quick turnaround in repairing these units themselves in 2 days and for \$800 in material. Efficiency is restored and enhanced and will be maintained for longer than untreated pumps.
