BELZONA PROTECTS TUBE SHEET AND TUBES

ID: 1056

Application: HEX-Heat Exchangers

Customer Location: Steel mill, Slovakia

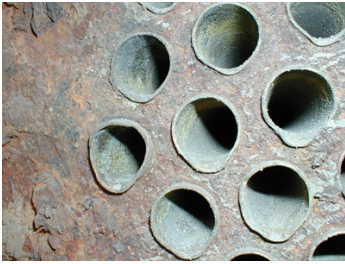
Corrosion problems were beginning on the tube sheet and inlet tubes (75 mm).

Damaged exchanger tube.

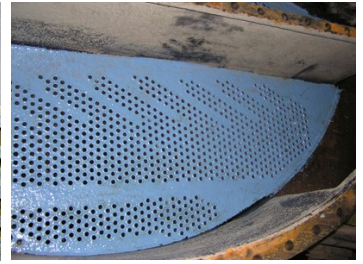
Top layer of Belzona 1341 product.

Belzona provided long term protection, increasing the life of the tube sheet and also inlet tubes, decreasing other repair and maintenance costs. Inspection after three years showed excellent protection being maintained.
