BELZONA REPAIR TO PIVOT PINS OF MILL

ID: 1057

Customer Location: *Ceramic tile manufacturer, Slovakia*
Application Date: *2004, 2005 & 2006*

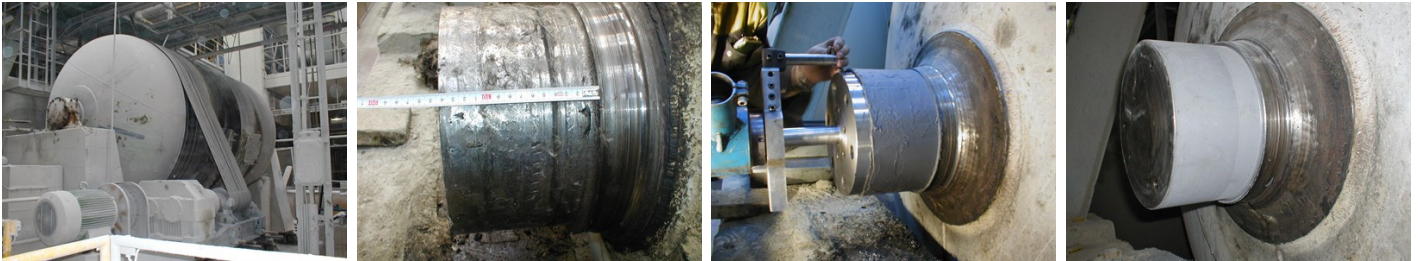
Photograph Descriptions

The two pivot pins supporting the crusher are damaged due to loading and working environment.

* An overall view on the mill , * An example of the excessive damage of the pins , * Belzona® 1111 ready to be machined , * The pivot pin prepared for operation ,

Application was carried out in accordance with Belzona Know-How System Leaflet MPT-1. Hand portable lathe was used to machine the pivot pins.

The traditional repair using welding and subsequent grinding of the pivot pins took 5 weeks. The repair using Belzona took 3 days, resulting into significant savings.
