COMPLETE REFURBISHMENT OF VACUUM PUMP WITH BELZONA

ID: 106

Industry: *Pulp & Paper*
Application: *PDP-Positive Displacement Pumps*

Customer Location: *Pulp and Paper Plant, Portugal*
Application Date: *July 1998*

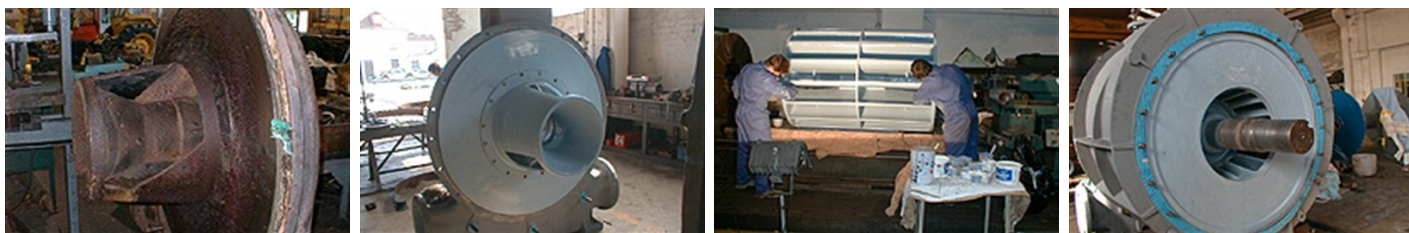
Photograph Descriptions

Extensive corrosion on all parts including rotor, end covers, and cones.

- * The degree of corrosion clearly evident on the head assembly ,
- * The refurbished head assembly ,
- * Application to rotor underway ,
- * The pump being re-assembled ,

Application carried out in accordance with Belzona Know-How system PDP-5.

Belzona application was carried out at a fraction of the cost of a new unit and erosion/corrosion resistance of Belzona® 1341 will extend life of the pump beyond that of an unprotected unit.
