PROTECTION OF CARBIDE MIXTURE TRANSFER EQUIPMENT WITH BELZONA

ID: 1065

Application: SHM-Solids Handling Machinery

Customer Location: Calcium Carbide producer, Slovakia

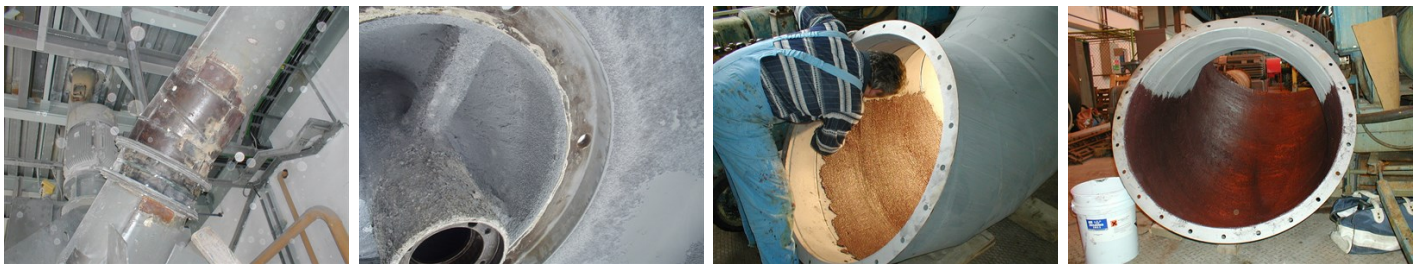
Photograph Descriptions

The highly abrasive carbide mixture wears tubes, pipe bends as well as the crusher itself.

- * Repair of the pipes was constantly required ,
- * The heavily damaged surface of the equipment ,
- * The application of Belzona® 1811 to pipe bend ,
- * The pipe bend ready for operation ,

Application was carried out in accordance with Belzona Know-How System Leaflet SHM-11.

Prior to the application it was required to change every 6 months the pipe sections as well as the parts of the crusher. Belzona application has prolonged the service life to 24 months, meaning that €24,000 was saved by customer over two years.
