BELZONA SOLUTION FOR NEUTRALIZATION TOWER

ID: 1066

Industry: *Chemical & Petrochemical*
Application: *TCC-Tanks and Chemical Containment Areas*
Substrate: *Steel*
Products: *Belzona® 4331 (Magma CR3)*

Customer Location: *Chemical plant, Slovakia*
Application Date: *2001, 2003, 2004, 2006*

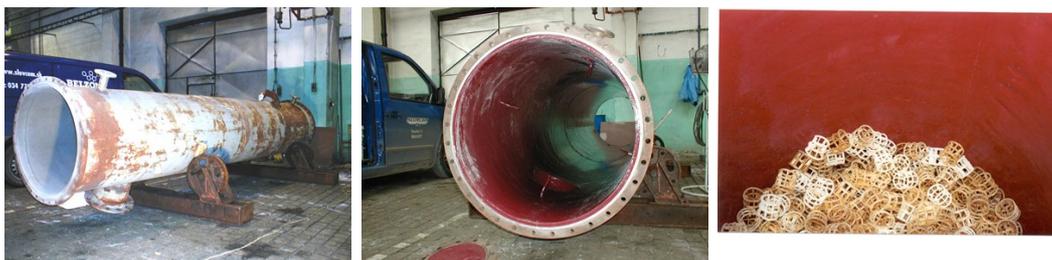
Photograph Descriptions

Corrosion caused by presence of aggressive chemicals including Vinyl Chloride, Sodium Hydroxide, Methyl Chloride and Hydrogen Chloride.

* Neutralizing tower after blasting operation , * Belzona® 4331 applied , * Ready to operate ,

The application was carried out in accordance with Belzona Know-How System Leaflet TCC-5

Customer carried out trials on various coatings and most were destroyed within weeks. Belzona® 4331 gave best results being intact after 2 years. Client has since coated all 4 towers with Belzona® 4331.
