# BELZONA RESTORES SAFETY VALVE SEAL

ID: 1068

Customer Location: Power plant, Bulgaria  
Application Date: June, 2005

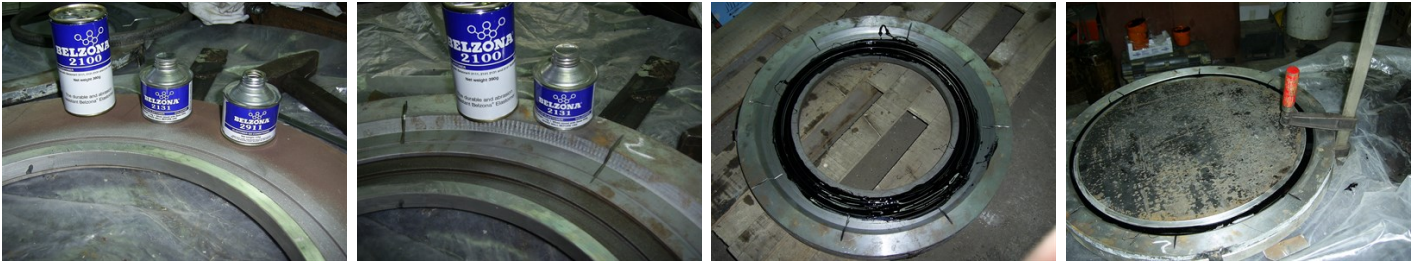
Damaged mating surface in the safety valve was allowing back-flow of water

\* The safety valve plate , \* The inner and outer forming rings put on the valve plate , \* Belzona® 2131 poured in the gap between two forming rings , \* The top forming plate clamped to form precise mating surface ,

Application was carried out in accordance with Belzona Know-How Leaflet GSS-1. Two forming rings(inner and outer to the valve diameter) were used to create the diameter profile and top plate used to form actual sealing face.

New valves were not available so the sealing surfaces were removed and Belzona® 2131 moulded to the original sealing profile. Belzona provided fast return to service. The alternative hot vulcanization required special equipment and extra time.
