# BELZONA PROTECTS CHEMICAL CONTAINMENT AREAS

Customer Location: Coal Power Plant, Galicia, Spain

Application: TCC-Tanks and Chemical Containment Areas

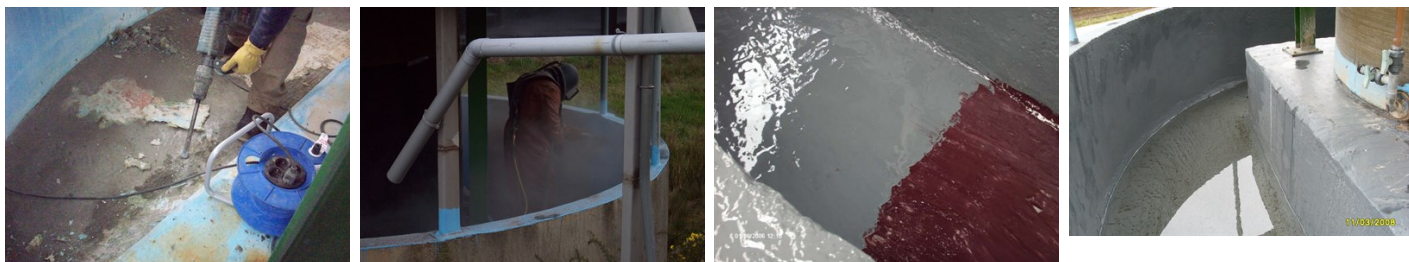
Occasional spills during the operations of filling up the tanks caused major damage to the previous coating

\* Removing the old coating , \* Blasting the surface to be coated , \* Applying the second layer of Belzona® 4311 over the first coat , \* One of the containment areas after one month ,

Four chemical containments for polyester tanks filled with sodium hypochlorite

Application was carried out in accordance with Belzona Know-How System Leaflet TCC-15.
