BELZONA REPAIR TO VERTICAL EXPANSION JOINT COMES OF AGE

Customer Location: University Hospital

Application: WPA-Wall Problem Areas

Vertical expansion joint between two cast concrete walls.

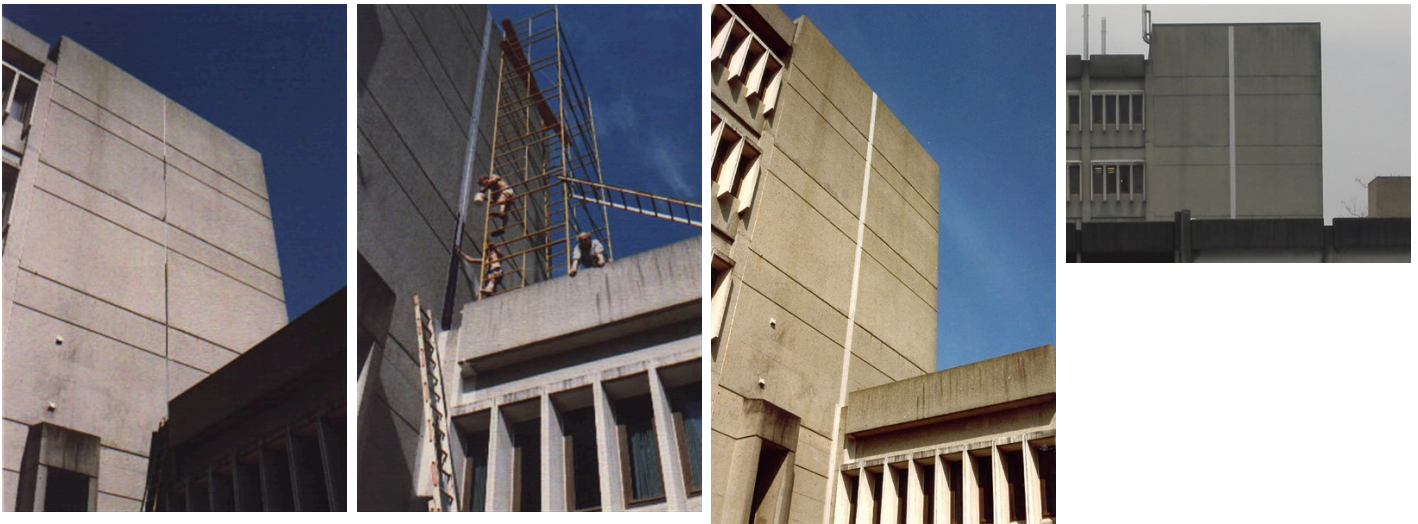
The expansion joint material used to seal the long vertical joint had become a perennial problem. The caulking material used could not withstand the constant movement.

- * General view of 140-ft wall and problem joint. ,
- * The spalled edges of the concrete were rebuilt with Belzona® 4111 before applying the Belzona® 3111 (Flexible Membrane System). ,
- * Complete application - The final coat was tinted for a closer match to the concrete. ,
- * Picture taken in 2008 showing present condition of the 21-year-old application. ,

Application was carried out using a modified version of Belzona Know-How System Leaflet WPA-1 and WPA-9.

This application has been in service since 1987 (21 YEARS) without the need for any additional maintenance.
