# BELZONA REPAIR TO VERTICAL EXPANSION JOINT COMES OF AGE

ID: 1076

Customer Location: University Hospital

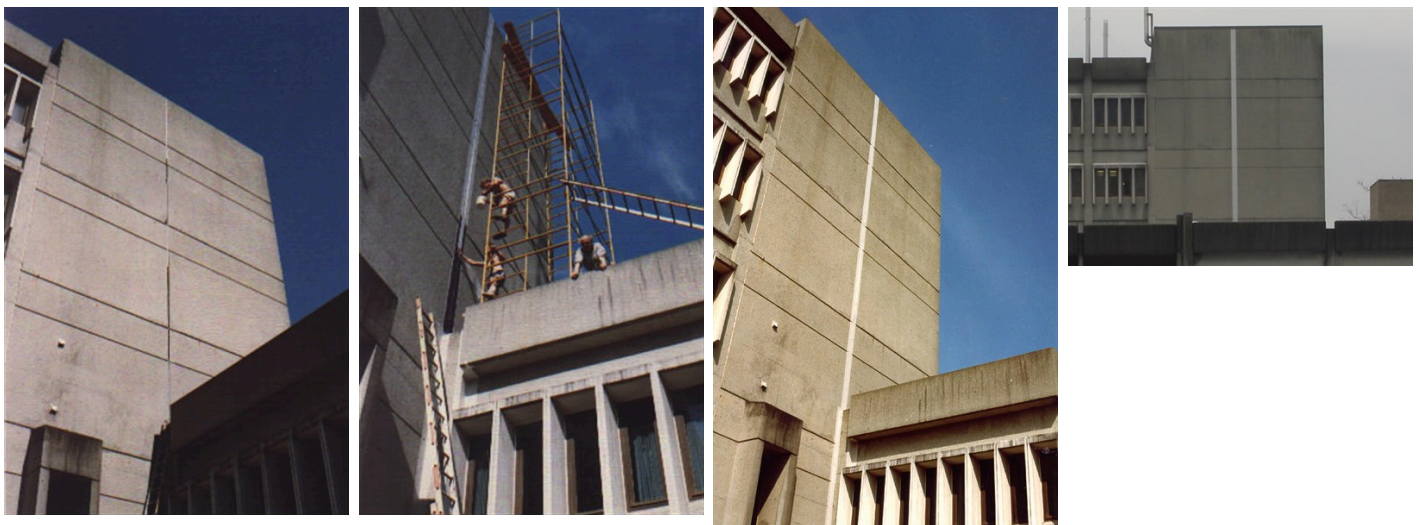
The expansion joint material used to seal the long vertical joint had become a perennial problem. The caulking material used could not withstand the constant movement.

- \* General view of 140-ft wall and problem joint. ,
- \* The spalled edges of the concrete were rebuilt with Belzona® 4111 before applying the Belzona® 3111 (Flexible Membrane System). ,
- \* Complete application - The final coat was tinted for a closer match to the concrete. ,
- \* Picture taken in 2008 showing present condition of the 21-year-old application. ,

Vertical expansion joint between two cast concrete walls.

Application was carried out using a modified version of Belzona Know-How System Leaflet WPA-1 and WPA-9.

This application has been in service since 1987 (21 YEARS) without the need for any additional maintenance.
