BELZONA FLEXIBLE MEMBRANE SEALS LEAKING CONCRETE DECK

ID: 1077

Leaking concrete deck over parking garage

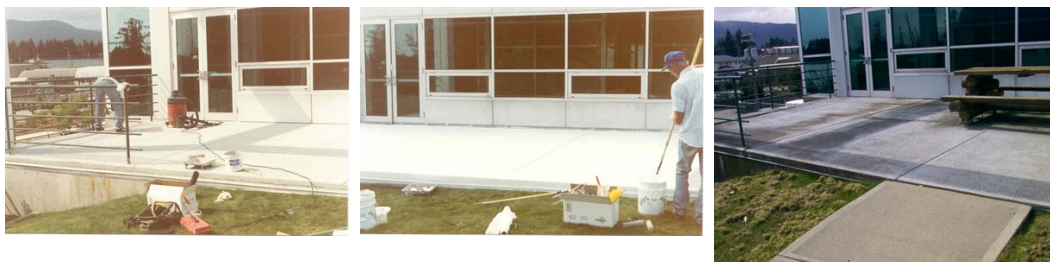
Photograph Descriptions

Water, leaking through the concrete deck, was falling on the cars parked beneath and damaging the paintwork

* The deck prepared by pressure washing , * After application of Belzona® 3911 to concrete surfaces and Belzona® 3921 Aluminum surfaces (window and door frames), Belzona® 3111 was applied , * View of deck taken in 2005 after 10 years of service ,

Application completed in accordance with a modified version of Belzona Know-How System Leaflet RPA-10.

Various crack sealing products had been tried with little little to no success.
A recent check in 2008 reveals the deck coating to still be in service.
