BELZONA® 1591 PROTECTS HEAT EXCHANGERS

ID: 108

Customer Location: Oil Refinery in Oman
Application Date: January 1999

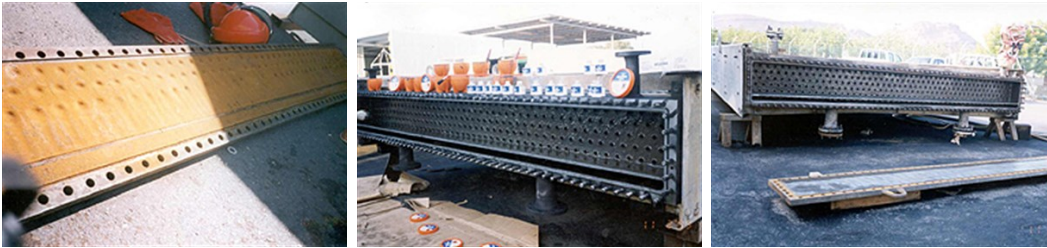
Photograph Descriptions

Severe erosion-corrosion of the tube sheet and end cover caused by the hot Hydrocarbon mixture.

- * The degree of erosion clearly evident on the end cover ,
- * Application of Belzona® 1591 underway ,
- * Application to tube sheet completed. End cover awaiting coating. ,

Application was carried out in accordance with Belzona System Leaflet HEX-1

The Belzona® 1591 was the only coating known to withstand the erosion-corrosion at the high temperatures involved. Three further units have since been treated.
