BELZONA PROTECTS AERATOR IN WATER TREATMENT PLANT

ID: 1081

Application: *SHM-Solids Handling Machinery*

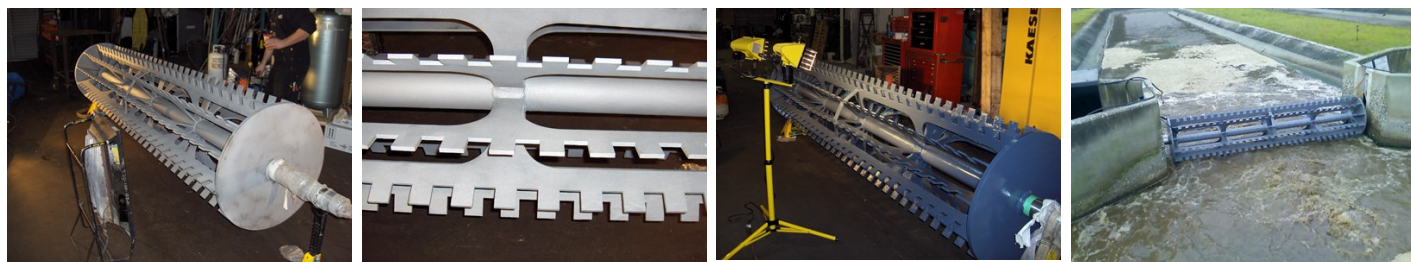
Photograph Descriptions

The welded component required protection from bi-metallic corrosion

* Completed aerator unit in the fabricating shop after grit blasting , * Close up view of the equipment , * Completed application, 2 coats of Belzona® 1321 , * Protected aerator in service ,

Application completed in accordance with Belzona Know-How System Leaflet SHM-11.

A similar piece of equipment built 6 years previously and protected with Belzona® 1321 had provided extremely good service.
