BELZONA PROTECTS CLARIFIER

ID: 1088

Customer Location: Chemical Plant, Italy

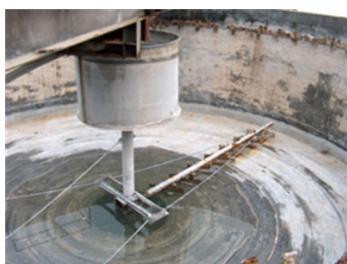
Concrete damaged by erosion and abrasion led to underground leakages with contaminated water.

- * Before Belzona ,
- * Application of Belzona® 4111 ,
- * Application of Belzona® 5811 ,
- * Completed application ,
