BELZONA PROTECTS CLARIFIER

ID: 1088

Customer Location: Chemical Plant, Italy
Application Date: November 2007

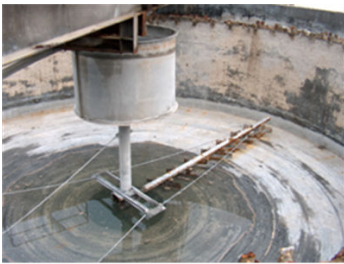
Concrete damaged by erosion and abrasion led to underground leakages with contaminated water.

- * Before Belzona ,
- * Application of Belzona® 4111 ,
- * Application of Belzona® 5811 ,
- * Completed application ,
