BELZONA PROVEN PROTECTION ON TURBINE RUNNER

Francis Turbine runner for a Hydro Electric Plant in Africa.

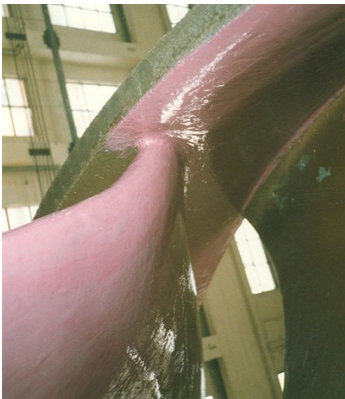
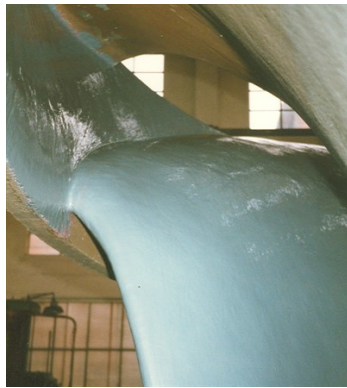
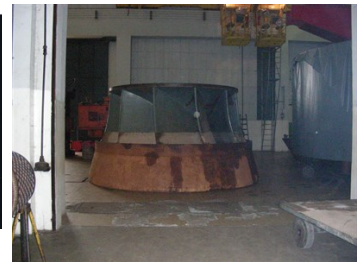
Photograph Descriptions

Coating protection required to deal with anticipated Erosion and Corrosion.

- * First coat ,
- * Second Coat applied ,
- * Completed Application ,
- * Coating after 20 years in service ,

Surface Preparation and Application was carried out accordance with the relevant IFU and in line with Belzona Know-How System Leaflet CEP-3.

The customer contacted the Distributor in September 2007 for a general inspection of the coating which indicated repair was

needed in areas. A proposal to refurbish with Belzona® 1321 has been made.
