# BELZONA REFURBISHES RAW JUICE HEATER

Industry: Sugar  
Application: HEX-Heat Exchangers  
Substrate: Cast Iron  
Products: \* Belzona® 1311 (Ceramic R-Metal) ,  
\* Belzona® 1321 (Ceramic S-Metal) ,

Customer Location: Sugar Cane Mill in Australia  
Application Date: 1997

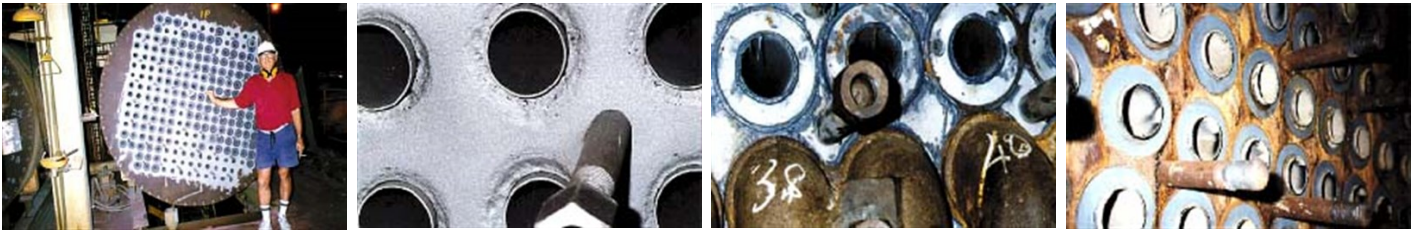
Erosion/corrosion of around tubes on tube sheet surface. Operation of heater proved ineffective and presented a safety hazard.

- \* Juice heater. ,
- \* Erosion around tubes. ,
- \* Forming technique used to rebuild and seal around tubes. ,
- \* View of tube sheet surface after one year in service. ,

The application was carried out in accordance with Belzona Know-How Leaflet HEX-1.

The Belzona repair eliminated the need for machining, which would have been both time consuming and costly.
