BELZONA REFURBISHES RAW JUICE HEATER

Industry: Sugar
Application: HEX-Heat Exchangers
Substrate: Cast Iron
Products: * Belzona® 1311 (Ceramic R-Metal) ,
* Belzona® 1321 (Ceramic S-Metal) ,

Customer Location: Sugar Cane Mill in Australia
Application Date: 1997

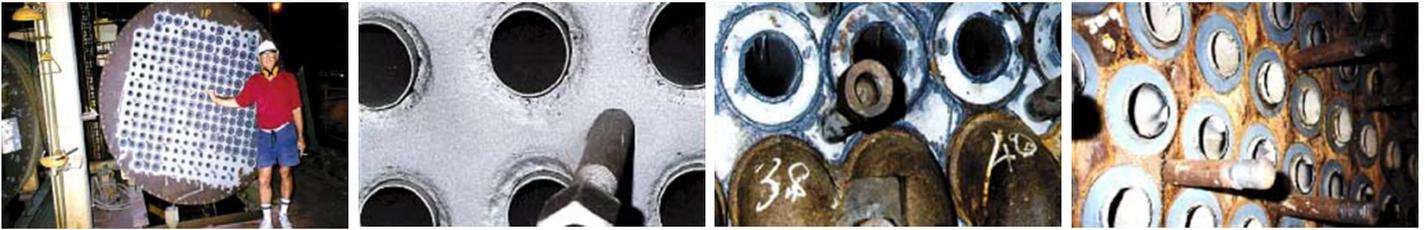
Photograph Descriptions

Erosion/corrosion of around tubes on tube sheet surface. Operation of heater proved ineffective and presented a safety hazard.

- * Juice heater. ,
- * Erosion around tubes. ,
- * Forming technique used to rebuild and seal around tubes. ,
- * View of tube sheet surface after one year in service. ,

The application was carried out in accordance with Belzona Know-How Leaflet HEX-1.

The Belzona repair eliminated the need for machining, which would have been both time consuming and costly.
