BELZONA PROTECTS EVAPORATORS IN DISTILLATION UNIT

ID: 110

Customer Location: National Oil Company
Application Date: May 1996

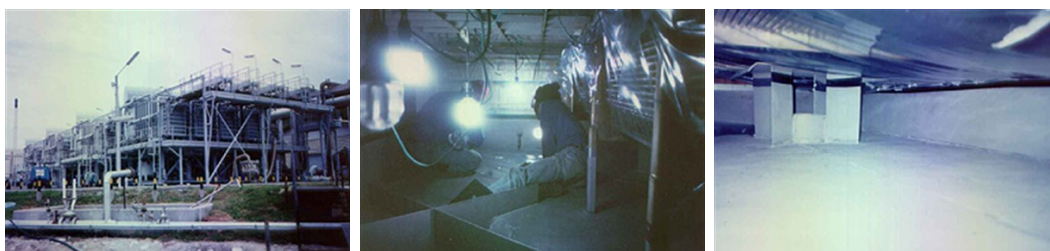
Photograph Descriptions

Floor plate in No. 4 Distillation unit was showing considerable corrosion and weld repairs, including welding in of new plate sections had already been carried out previously.

- * General view of the 4 Distiller units. ,
- * Work underway inside the Evaporator. Note low temperature lighting used to minimise air temperature. ,
- * Belzona® 1391 applied to base and 30cms up side of all steelwork in unit. ,

Application was carried out in accordance with Belzona® Know-How Leaflet TCC-3. Extreme care was taken to ensure all salt contamination was removed and de-humidification equipment installed to prevent moisture contamination during application.

Recent inspection has shown Belzona® 1391 in perfect condition and customer can now look forward to many years service from the units without constant shut-downs for weld repairs. The other 5 units will also be coated shortly with Belzona® 1391.
