BELZONA SEALS PAPER MACHINE LEAKS

ID: 1105

Customer Location: Paper Mill, Poland

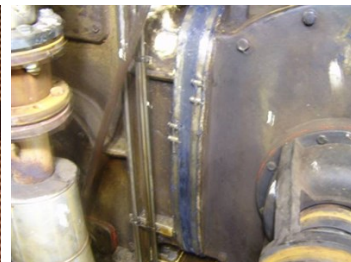
Leaking crank casing due to inadequate sealing. Significant oil losses necessitated repairs several times per year.

* The leaking casing , * Repair using Belzona® 2211 , * Belzona® 2211 , * Final repair situation ,

Application was carried out in accordance with Belzona System Leaflets ENC-7 & GSS-2. An effective sealing solution was found by bonding the rubber gasket into position using Belzona® 2211. Casing defects were rectified using Belzona® 1111.
