# BELZONA TEMPORARY SOLUTION TO A SERIOUS PROBLEM STILL IN SERVICE 10 YEARS LATER

Customer Location: *Canadian Navy*

Application: *FPA-Floor Problem Areas*

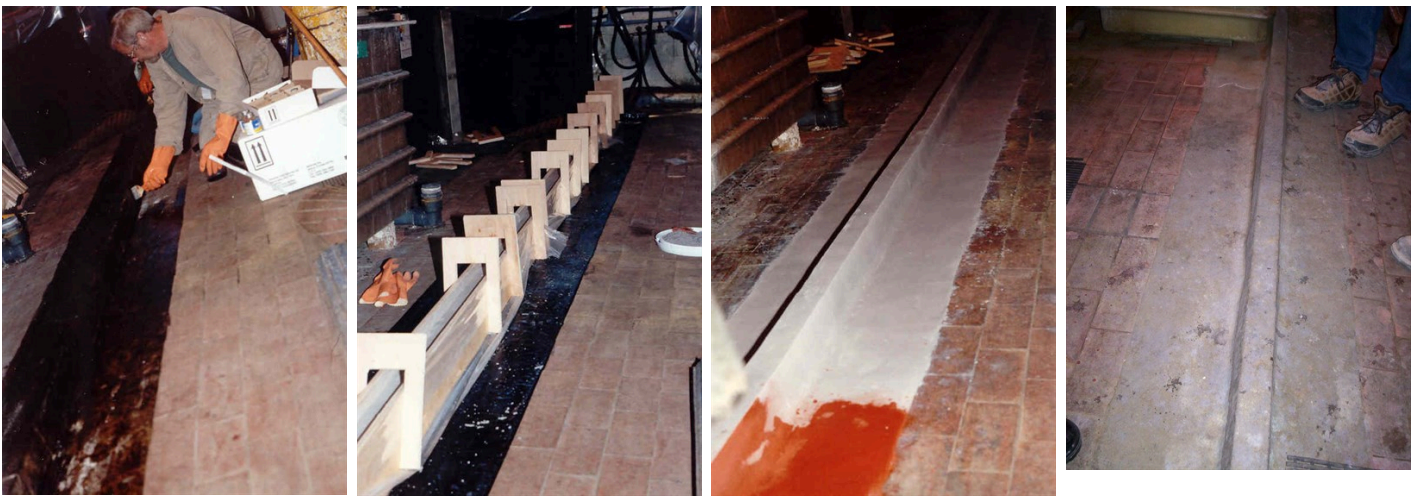
\* The cracked membrane was repaired with two coats of Belzona Elastomer , \* A pony wall was built using Belzona® 4131 , \* The entire rebuilt area was overcoated with two coats of Belzona® 4311 , \* View of the repair taken 10 years later showing it to be still in excellent condition ,

Customer had received a violation certificate for cracks in the floor and damage to a rubber membrane beneath a chemical plating facility

Application was carried out in accordance with Belzona Know-How System Leaflets FPA-3, -5 & -6. Rubber membrane was sealed with Elastomer and low retaining wall (pony wall) was constructed.

This application, though deemed temporary at the time has been in service for 10 years without the need for any maintenance.
