# BELZONA PROTECTS BLOWER HOUSING FROM CHEMICAL ATTACK

ID: 1108

Customer Location: Zinc Smelter - British Columbia, Canada  
Application Date: 2007

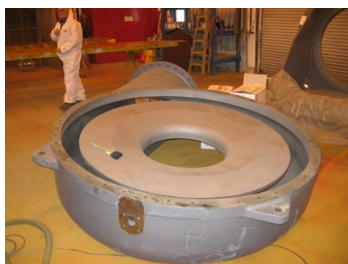
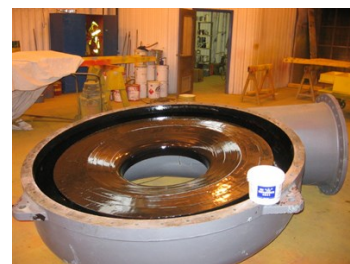
Hot acid mist was attacking the unprotected cast iron casing.

- \* The blower housing grit blasted and ready for application ,
- \* The backing plate grit blasted and ready for application ,
- \* Blower housing with 1st coat of Belzona® 4341 (Red) applied ,
- \* Blower housing with 2nd coat of Belzona® 4341 (Black) applied ,

Application was carried out in accordance with Belzona Know-How System Leaflet FBC-2.
