# BELZONA BECOMES A PERMANENT FIXTURE ON PUMPS

ID: 111

Customer Location: Power Plant in Virginia

Main cooling water pumps

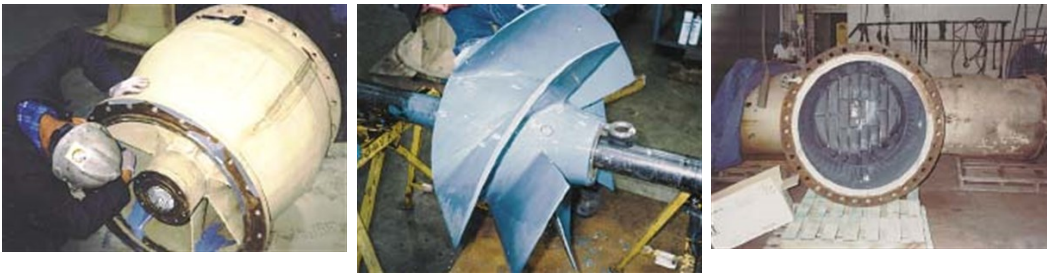
\* Application of Belzona® 1341 to a diffuser bowl begins. Finishing touches to an impeller shown here. Flow diverters and all internal components were protected with Belzona® 1341. ,

The pumps were exhibiting premature wear patterns which were not expected to happen until after 15 years of operation.

Three pumps were rebuilt in 1992. In 1995, one pump was pulled out of service, and after three years of operation, the Belzona® 1341 coating was still in excellent condition and required no touch-up.
