BELZONA SCREED REBUILDS DETERIORATING FLOORS

ID: 1111

Customer Location: *Supermarket, British Columbia, Canada*
Application Date: *2007*

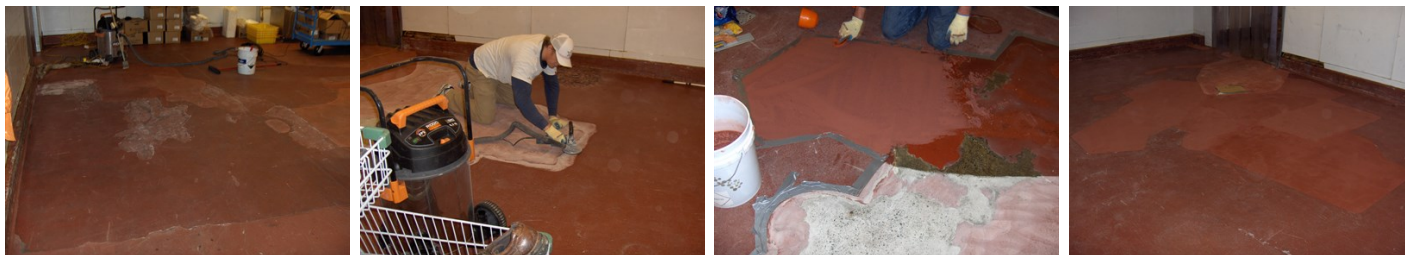
Photograph Descriptions

Water trapped beneath the red floor coating was causing odor and health concerns.

* General view of problem floor showing delamination areas , * Preparation of floor in progress using a Vacu-Grinder , * Application of Belzona® 4131 Magma Screed in progress , * Completed application ,

The original red epoxy coating was delaminating.

Application completed in accordance with Belzona Know-How System Leaflet FPA-1. Heat lamps were used to accelerate the cure to ensure area ready for use the following day.

Belzona Magma Screed provides hard wearing surface that was applied overnight so causing minimum disruption to the store.
