# BELZONA SCREED RESTORES DETERIORATED FLOORS

ID: 1112

Customer Location: *Supermarket, British Columbia, Canada*  
Application Date: *2007*

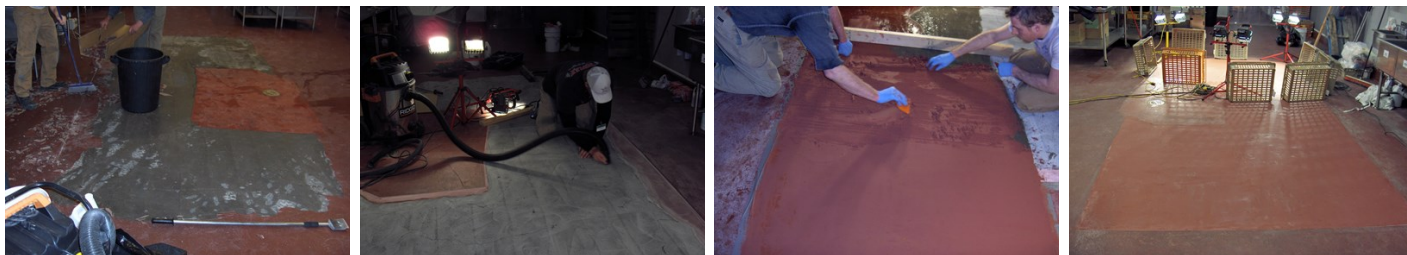
## Photograph Descriptions

*Water trapped underneath the failed coating was causing odour and health concerns.*

\* The delaminated coating was removed with scrapers , \* The area was ground with a Vacu-Grinder , \* Application of Belzona Magma Screed in progress , \* Completed application with heat lamps in place. ,

The red epoxy floor coating was delaminating.

Application was carried out in accordance with Belzona Know-How System Leaflet FPA-1.  
Heat lamps were used to accelerate cure to ensure area ready for use following day.
