# BELZONA GIVES NEW LIFE TO RUBBER ROOF

ID: 1120

Application: RPA-Roof Problem Areas

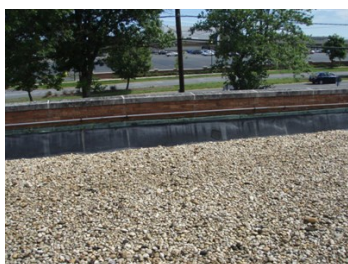
Roof had started to leak due to holes in the rubber membrane. The customer wanted the roof fixed quickly and without tearing off the old roof.

\* Existing rubber roof with ballast rocks , \* Rocks removed, membrane fastened and primed , \* 1st coat of Belzona® 3111 applied , \* Completed roof project ,
