BELZONA WATERPROOFS CONTROL ROOM ROOF

ID: 113

Application: RPA-Roof Problem Areas

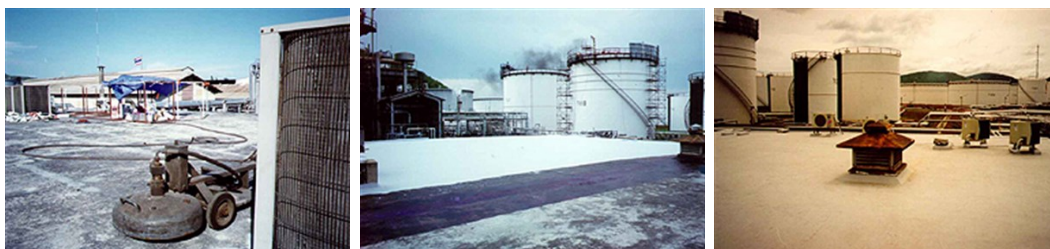
Photograph Descriptions

Water penetration through various cracks and at equipment support pads. Leakage was also suspected through 120 linear meters of expansion joints.

- * The pneumatic scabbler used to prepare the roof surface ,
- * Application underway with part of the roof conditioned and part coated with Belzona® 3111 ,
- * The completed application. Note the seamless finish achieved over the many equipment supports ,

Flat concrete slab roof over control room

Application was carried out in accordance with Belzona Know-How Leaflets RPA-1, RPA-2, RPA-6, RPA-8, RPA-10 and RPA-11.
