BELZONA REFURBISHES MILITARY DOG KENNELS

ID: 1142

Industry: Buildings & Structures
Application: FPA-Floor Problem Areas
Substrate: Concrete and Cinder Block
Products: Belzona® 4111 (Magma Quartz)<div>Belzona® 5111 (Ceramic Cladding)</div><div>Belzona® 5811 (Immersion Grade)</div>

Customer Location: Military Base, North Alabama
Application Date: April 2006

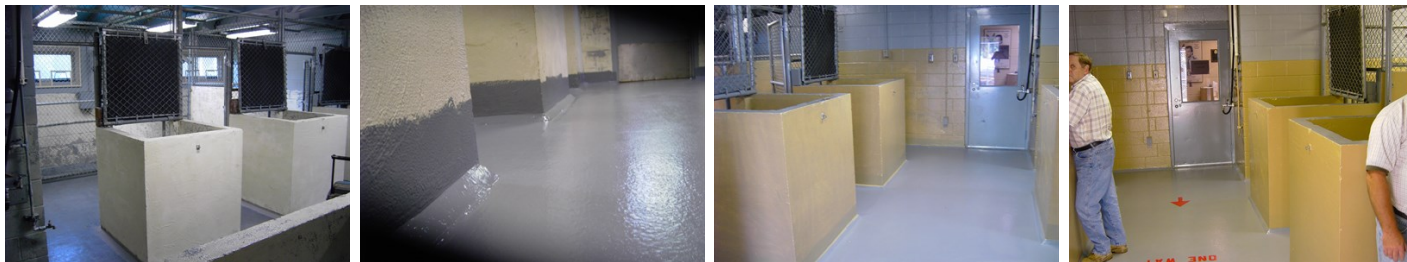
Photograph Descriptions

* Prepped and ready to coat , * Floor and coves covered , * Almost complete, walls being coated , * All done! Ready to turn over to the owners ,

To create a non-slip surface that did not damage paws, different aggregates were tried before settling on a non-standard Belzona one that was found to be ideal. Coves between wall and floor were formed and Belzona® 5111 provided stain resistant finish.
