# BELZONA REFURBISHES MILITARY DOG KENNELS

ID: 1142

Industry: *Buildings & Structures*  
Application: *FPA-Floor Problem Areas*  
Substrate: *Concrete and Cinder Block*  
Products: *Belzona® 4111 (Magma Quartz)<div>Belzona® 5111 (Ceramic Cladding)</div><div>Belzona® 5811 (Immersion Grade)</div>*

Customer Location: *Military Base, North Alabama*  
Application Date: *April 2006*

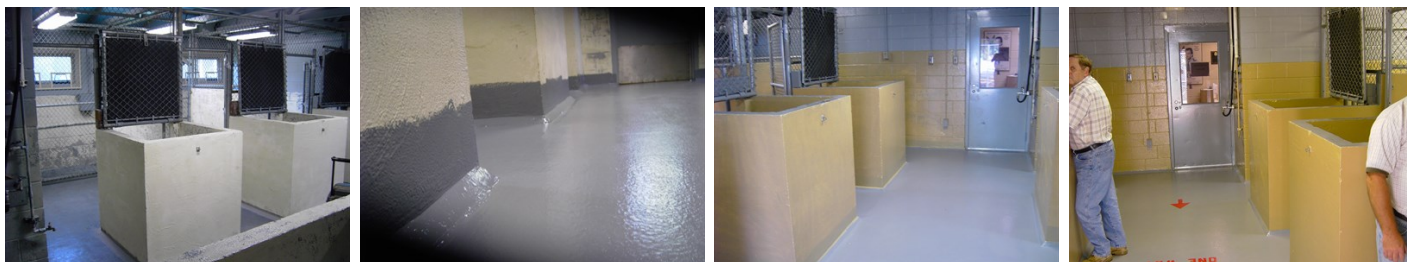
## Photograph Descriptions

\* Prepped and ready to coat , \* Floor and coves covered , \* Almost complete, walls being coated , \* All done! Ready to turn over to the owners ,

To create a non-slip surface that did not damage paws, different aggregates were tried before settling on a non-standard Belzona one that was found to be ideal. Coves between wall and floor were formed and Belzona® 5111 provided stain resistant finish.
