BELZONA PEDESTRIAN WALKWAY

ID: 1144

Application: *FPA-Floor Problem Areas*

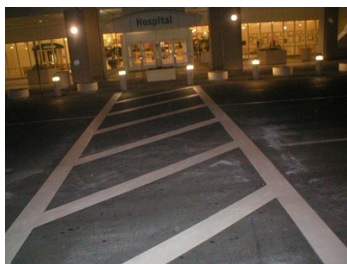
* Walkway marked out and surface prepared , * Belzona system being applied , * Application completed , * Still in excellent condition 2 years later ,

Application was carried out using a modified version of the Belzona Know-How System Leaflet FPA-8. A slurry mix of Belzona® 4111 tinted white was used.

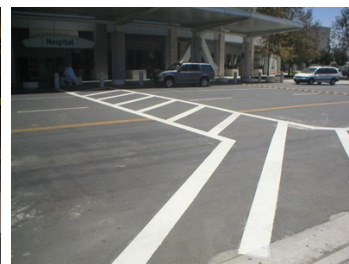
Belzona system provided the hard wearing non-slip surface required in this critical area.
System still in excellent condition when inspected 2 years later.
