BELZONA PEDESTRIAN WALKWAY

ID: 1144

Customer Location: *Hospital, San Bernardino, California
U.S.A.*

Application: *FPA-Floor Problem Areas*

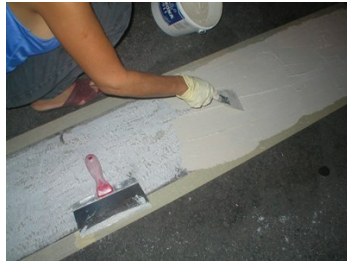
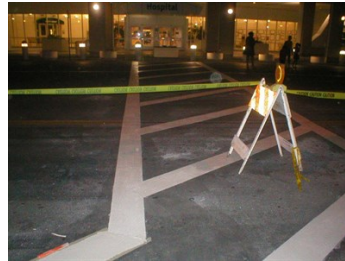
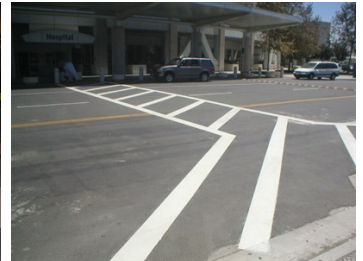
Photograph Descriptions

A hard wearing non-slip surface required to provide a safe route into the hospital

* Walkway marked out and surface prepared , * Belzona system being applied , * Application completed , * Still in excellent condition 2 years later ,

Application was carried out using a modified version of the Belzona Know-How System Leaflet FPA-8. A slurry mix of Belzona® 4111 tinted white was used.

Belzona system provided the hard wearing non-slip surface required in this critical area.
System still in excellent condition when inspected 2 years later.
