BONDING FAIRLEADS WITH BELZONA

ID: 1148

Customer Location: Shipyards, France
Application Date: May 2008

37 Meters long Yacht

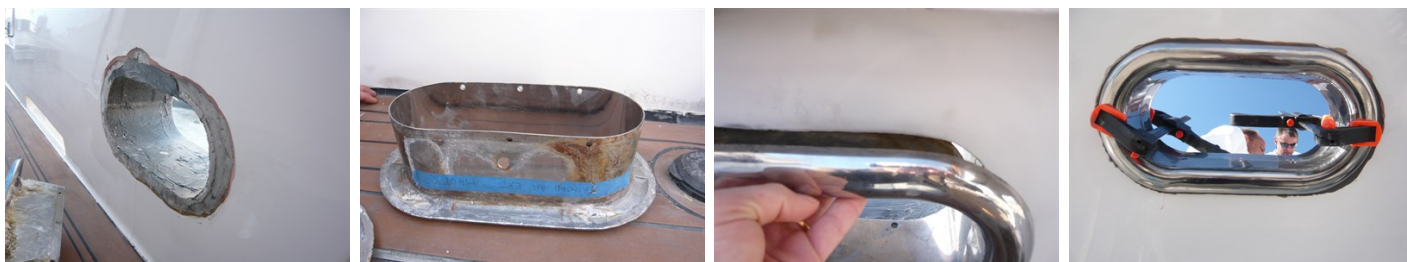
Photograph Descriptions

Fairleads have been dismantled in order to realise repairs to the hull. A rebuilding and bonding material was then necessary to fill gaps when fairleads were replaced.

- * Fairlead pocket ,
- * Fairlead before application ,
- * Application underway ,
- * Fairlead clamped in place during the cure process ,

Application was carried out in accordance with a modified Belzona Know How System GSS-9.

The pourable chocking option usually considered by the customer could not be applied in this situation due to the thickness of adhesive required. Belzona® 1111 has no limitation in thickness when applied in such an environment,
