Belzona to the Rescue for Higher Learning

Customer Location: University Central Energy Plant -
Laramie, Wyoming USA

Application: CEP-Centrifugal Pumps

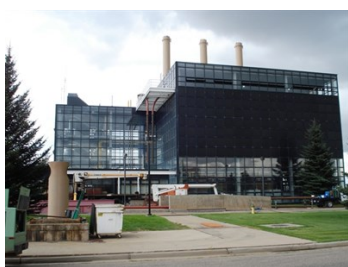
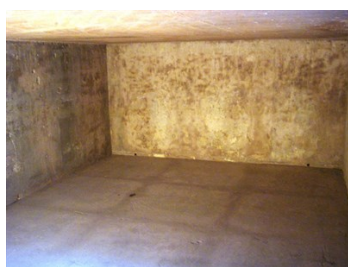
Photograph Descriptions

After one short year in service, the original coating was delaminating in large sheets exposing the concrete and rebar to the corrosive action of the hot condensate.

- * Central energy plant ,
- * Condensate tank after abrasive blasting ,
- * Belzona® 1391 after pinhole testing ,
- * Belzona application two years later requiring minor touchup due to substrate degradation ,

Belzona® 1391 and Belzona® 1511 were applied in accordance with a modified version of Belzona Know-How System Leaflet VPF-2.

The original failed coating was discovered with only four days remaining in the annual shutdown. Belzona was easily able to recoat the tank in this limited timeframe and to date has given two years of trouble-free service.
