BELZONA CONTAINER SHIP RUDDER REPAIRS

ID: 116

Very severe erosion/corrosion of steel components of the ship's rudder

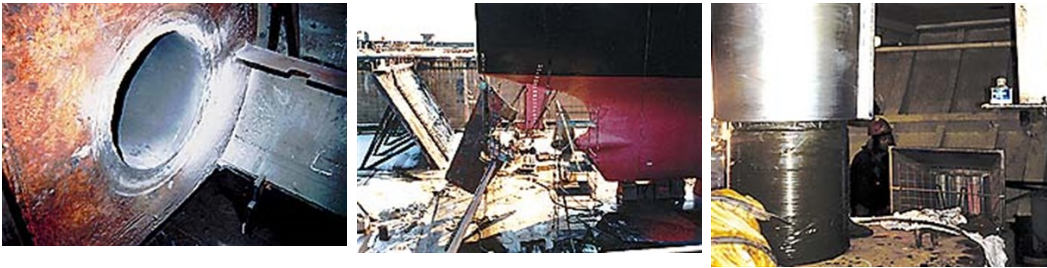
Photograph Descriptions

- * Pintle pin bore after molding, 95-99% contact per ABS Surveyor ,
- * Rudder being installed on ship after pintle pin repairs ,
- * Rudder stock bore with Belzona® 9411 (Release Agent) ,

The application was carried out in accordance with Belzona Know-How Leaflets SOS-3 and MPT-1.

Conventional repairs using only welding and machining/field boring would have required a very long stay in drydock, causing severe disruption of cargo schedule with huge losses.
