# BELZONA PROTECTS DIGESTER

ID: 1162

Application: TCC-Tanks and Chemical Containment Areas

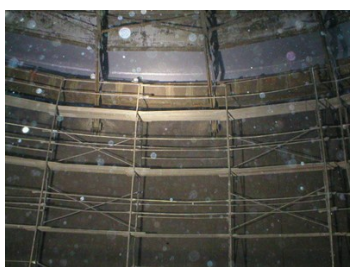
Severe corrosion occurring in vapour space at top of tank on walls and underside of the roof. Also internal pipework being attacked.

- \* Top of digester walls coated after grit blasting ,
- \* The pipes waiting to be coated ,
- \* Tank top was also coated with Belzona® 5811 ,

Application was carried out in accordance with Belzona Know-How System Leaflet TCC-5.
