BELZONA PROTECTS DISULFIDE SEPARATOR DRUM

Customer Location: Refinery - Westlake, Louisiana U.S.A.

Application Date: October 2007

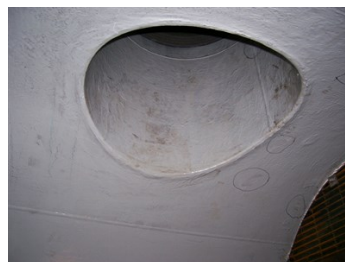
Chemical attack in the vapor space of this drum was evident after 5 years in service.

* Severe pitting on the vessel roof , * Severely corroded vessel to chimney joint , * Completed chimney stack , * Completed vessel roof ,

Application was carried out in accordance with Belzona Know-How System Leaflet TCC-3.

The Belzona® 5891 application was completed in a limited three day time-frame towards the end of a Merox Unit Turnaround.

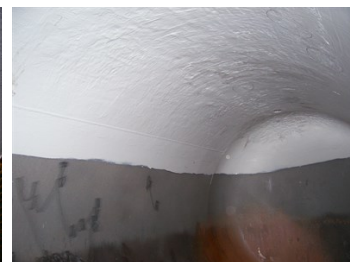
Corrosion and severe pitting on the inside of a process drum.
