# BELZONA PROTECTS DISULFIDE SEPARATOR DRUM

Customer Location: Refinery - Westlake, Louisiana U.S.A.

Application Date: October 2007

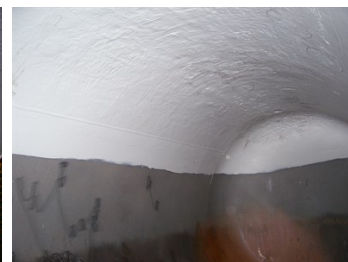
Chemical attack in the vapor space of this drum was evident after 5 years in service.

\* Severe pitting on the vessel roof , \* Severely corroded vessel to chimney joint , \* Completed chimney stack , \* Completed vessel roof ,

Corrosion and severe pitting on the inside of a process drum.

Application was carried out in accordance with Belzona Know-How System Leaflet TCC-3.

The Belzona® 5891 application was completed in a limited three day time-frame towards the end of a Merox Unit Turnaround.
