BELZONA® 4111 AFTER 15 YEARS

ID: 1172

Customer Location: Kiel Center in 1993, Scott Trade Center
Today, St. Louis, Missouri U.S.A.

Application: FPA-Floor Problem Areas

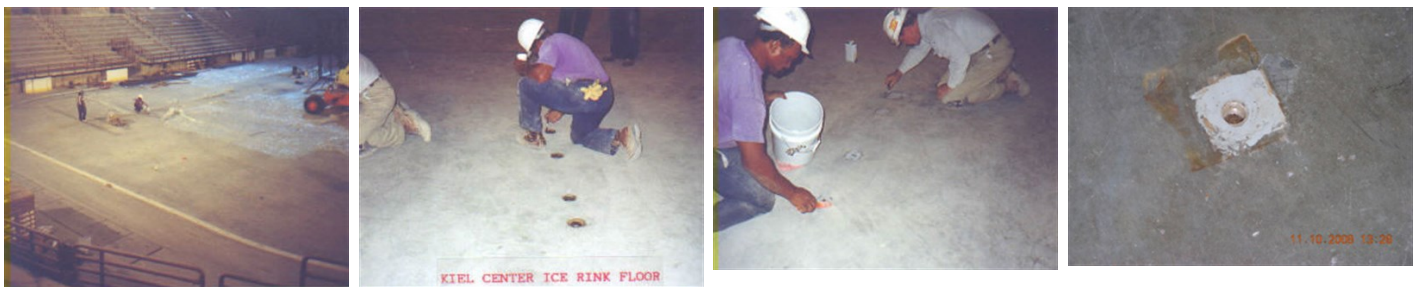
Photograph Descriptions

The concrete floor was mistakenly poured 3/4" on top of the anchors for the hockey dasher boards (two sizes, one for the NHL, the other for Olympic events) & circus tie down anchors.

- * Overall view of the floor in 1993 ,
- * Anchor points being chipped out ,
- * Starting the repairs ,
- * Typical Belzona anchor 2008 ,

Application was carried out in accordance with Belzona Know-How System Leaflet FPA-10. The floor was laid out to expose the more than 700 anchor locations. The concrete chipped out to expose the anchors. Release agent treated all-thread was used to form anchor thread in the Belzona® 4111.
