OLD APPLICATION MEETS NEW BELZONA APPLICATION

ID: 1174

Industry: Buildings & Structures
Application: FPA-Floor Problem Areas

Customer Location: Railroad in Saint Paul, Minnesota U.S.A.
Application Date: 1996 and 2008

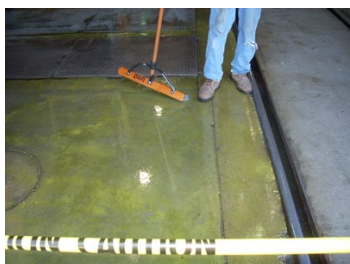
- * Preparing the surface ,
- * Taping off edges ,
- * Patching holes before coating ,
- * Old Belzona® 4411 on ramps meets new Belzona® 5231 on workshop floor ,

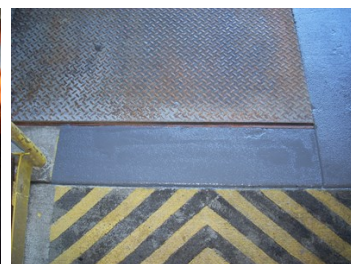
The ramps where done over 12 years ago and still in great condition saving time and money spent re-doing them repeatedly with systems. The floor has shown to be a safety benefit that also is easier and faster for crews to clean.
