BELZONA SEALS PACKING FACILITY

ID: 1175

Industry: General Industry
Application: RPA-Roof Problem Areas
Substrate: Aluminum
Products: Belzona® 3111 (Flexible Membrane)

Customer Location: Cement Company, Miami, Florida U.S.A.
Application Date: April 2008

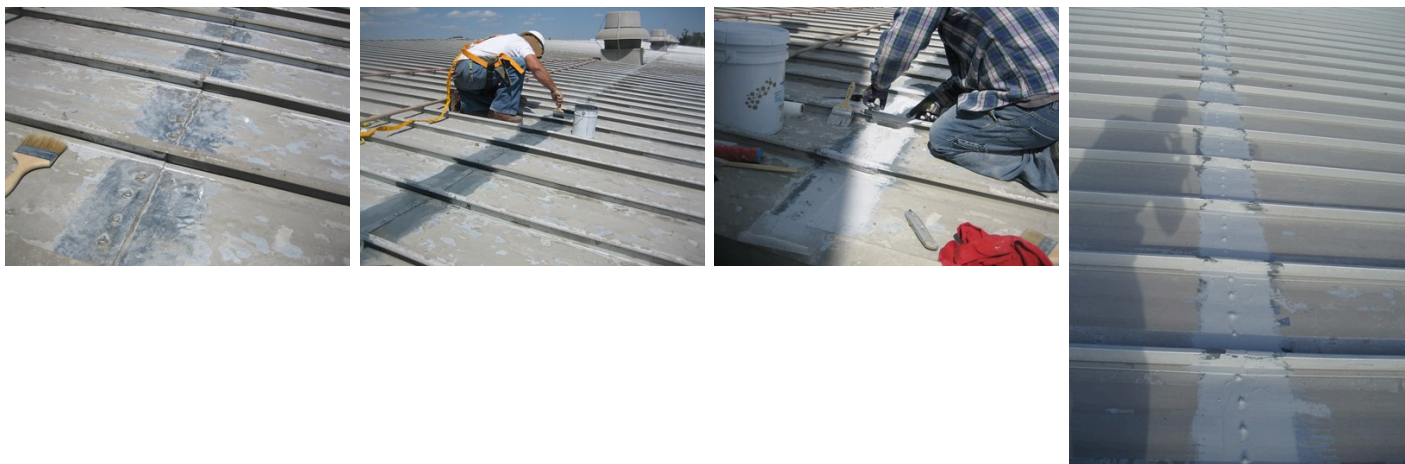
Photograph Descriptions

Roof was leaking through the seams and joints.

* Uncoated seams , * Belzona® 3921 (GSC Conditioner) being applied , * Seams being coated with Belzona® 3111 and reinforced with Belzona® 9311 , * Finished application. ,

Application was carried out in accordance with Belzona Know-How System Leaflet RPA-1.
