VERY OLD BELZONA TUBE SHEET REPAIR

ID: 1176

Customer Location: Petrochemical Plant, Plaquemine,
Louisiana U.S.A.

Application: HEX-Heat Exchangers

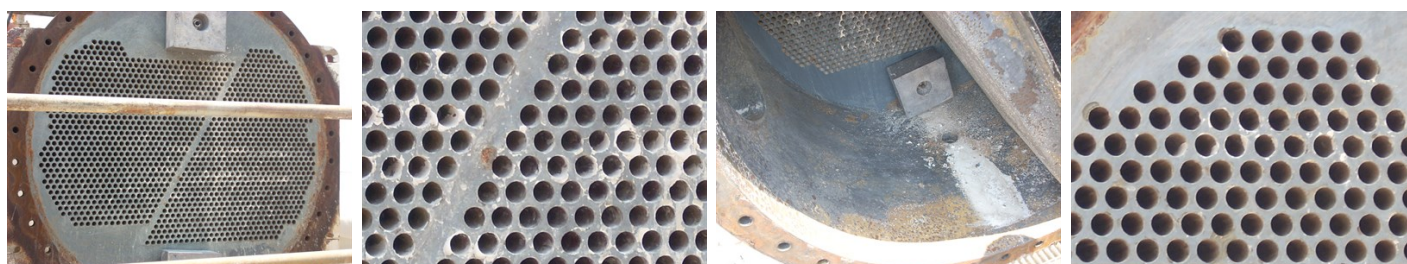
Photograph Descriptions

The tube sheet was suffering from bi-metallic corrosion and was in need of protection.

- * Rear of Condenser ,
- * Close up of sheet ,
- * Front of Condenser ,
- * Close up of sheet ,

This carrier condenser was coated in order to prolong the life of the unit.

The application was carried out in accordance with Belzona Know-How System Leaflet HEX-1.

This application occurred in 1973, which makes this a successful repair that is 35 years old. Replacement costs for a new unit is approximately \$350,000, and a Belzona repair today would cost the customer about \$25,000. For this one low cost, the customer saved replacement costs and downtime for many years. This particular unit is set for retirement in a January 2009 turnaround.
