BELZONA CAVITATION DAMAGE REPAIRED ON CRUISE SHIP PROPELLERS

ID: 118

Application: SOS-Ships and Offshore Structures

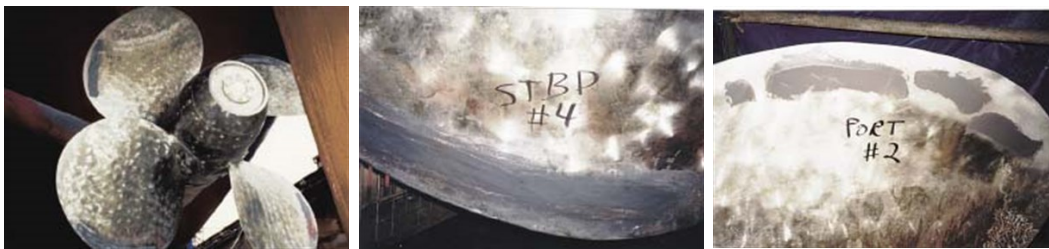
Photograph Descriptions

Propellers on cruise ship had cavitation damage on all four blades of both propellers.

- * Starboard propeller after grinding ,
- * #4 starboard propeller after Belzona® 1311 application ,
- * #2 port propeller after Belzona® 1311 application ,

The application was carried out in accordance with Belzona Know-How Leaflet SOS-1.

Repairs were accepted by Lloyds Register surveyor and by Russian Certification Society. About 1 kg of Belzona® 1311 (Ceramic R-Metal) (about \$170) was used.
