# BELZONA REBUILDS AND PROTECTS EXHAUST ON YACHT

ID: 1181

Industry: Marine

Application: SOS-Ships and Offshore Structures

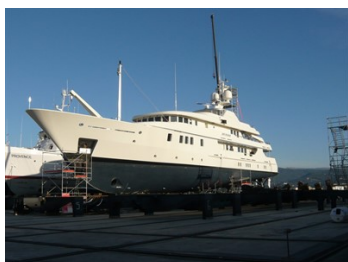
Severe corrosion caused by hot exhaust gas and salt water, led to critical loss of steel.

\* The yacht in dock , \* Initial state of exhaust pipe , \* Pitting clearly evident after blasting , \* Final result after rebuilding with Belzona® 1511 and coating with Belzona® 1391 ,
