BELZONA PROTECTS CONDENSOR JOINT FOR TWENTY YEARS

Customer Location: Nuclear Plant, USA

Application: VPF-Valves, Pipes and Fittings

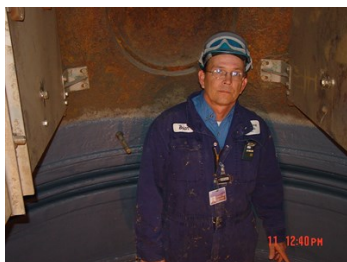
Joints could not be replaced in the short nuclear plant refueling outage. Corrosion had caused holes in the metal expansion joints.

* The original repair , * Overall view of the repair , * Rebuild with Belzona® 1311 , * Two coats of Belzona® 1321 applied over the joints ,

Carbon Steel expansion joints below the condensor corroding due to bimetallic corrosion.

First repair lasted 20 years. Although the unit had been down 10 of those years. When the unit was restarted the engineers inspected the old Belzona and found it in excellent shape with only minor damage. It was decided to remove the old Belzona and rework the project. A dozen joints were repaired and coated.
